# Manhole Inspection Summary

Manhole # S01AA2009MH

**Location** Address: **6320 WIRT AVE**

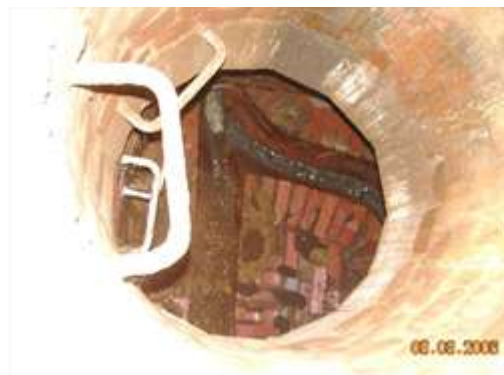
Top View

Evidence of surcharge - Bench debris.  
Channel debris.

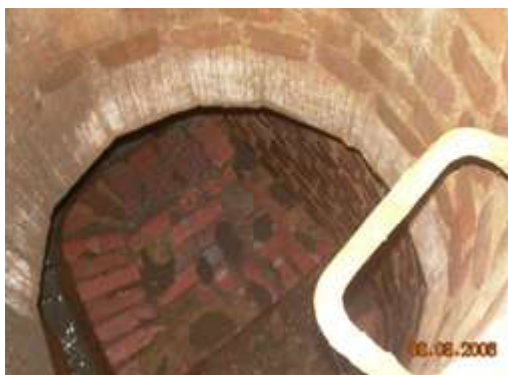
Defect

Infiltration: ☐ None ☒ **Joint** ☐ Cracks ☐ Mortar ☐ Roots ☐ Wall

Infiltration: ☐ None ☐ Joint ☐ Cracks ☒ **Mortar** ☐ Roots ☒ **Wall**

Adjustment and Barrel infiltration.

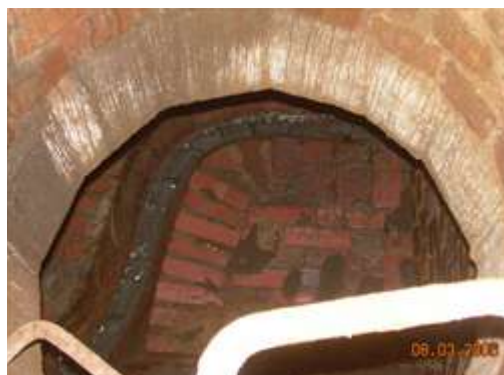
Defect

Adjustment and Barrel infiltration.

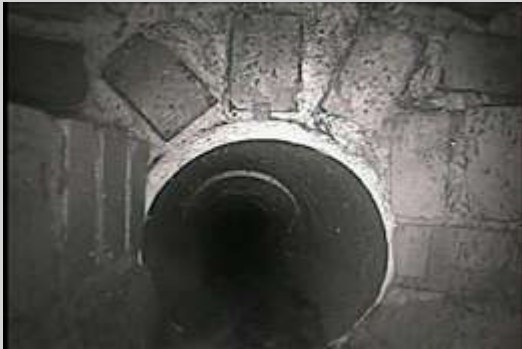
### 8 in. Circular Gravity Sewer Pipe Out @ 12 O'Clock

Invert Depth: **9.98** (ft.) Flow Characteristics: **Slow**

Infiltration: **None** Pipe Seal Cond: **Unknown**

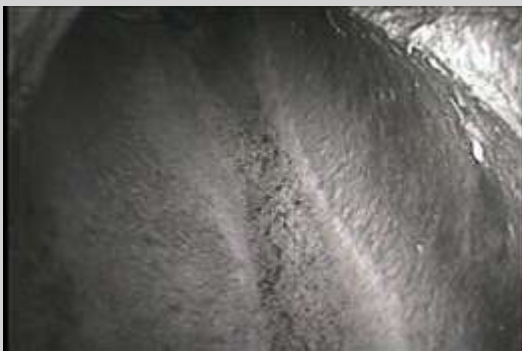
### 8 in. Circular Gravity Sewer Pipe In @ 4 O'Clock

Invert Depth: **8.60** (ft.) Flow Characteristics: **Slow**

Infiltration: **None** Pipe Seal Cond: **Unknown**

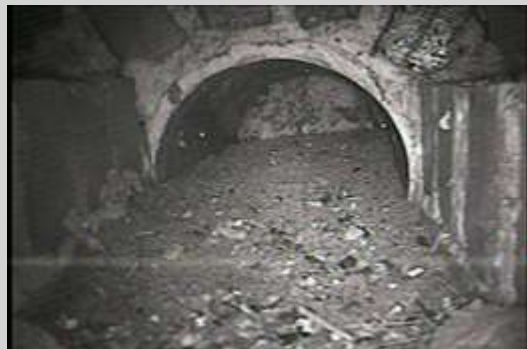
Pipe In @ 6 O'Clock

Connects To: **Stub connection / abandoned**
